Roof framing defect

Roof framing – an example of a defect that was picked up in a pre-purchase inspection

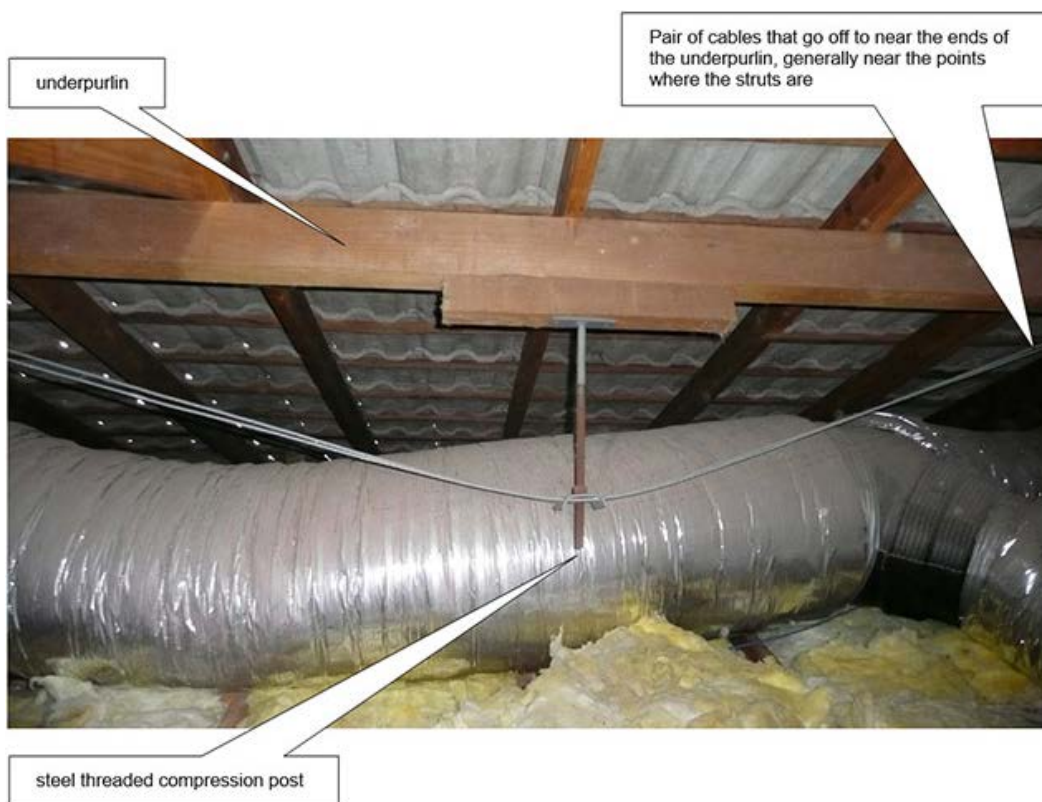
In some roof systems, the underpurlins are strengthened by a bracing system that comprises a couple of steel cables and a compression post. The cables are tightened by a fitting that is screwed down by the roof carpenter and the tension in the cables can be adjusted if necessary to get the alignment of the roof right.

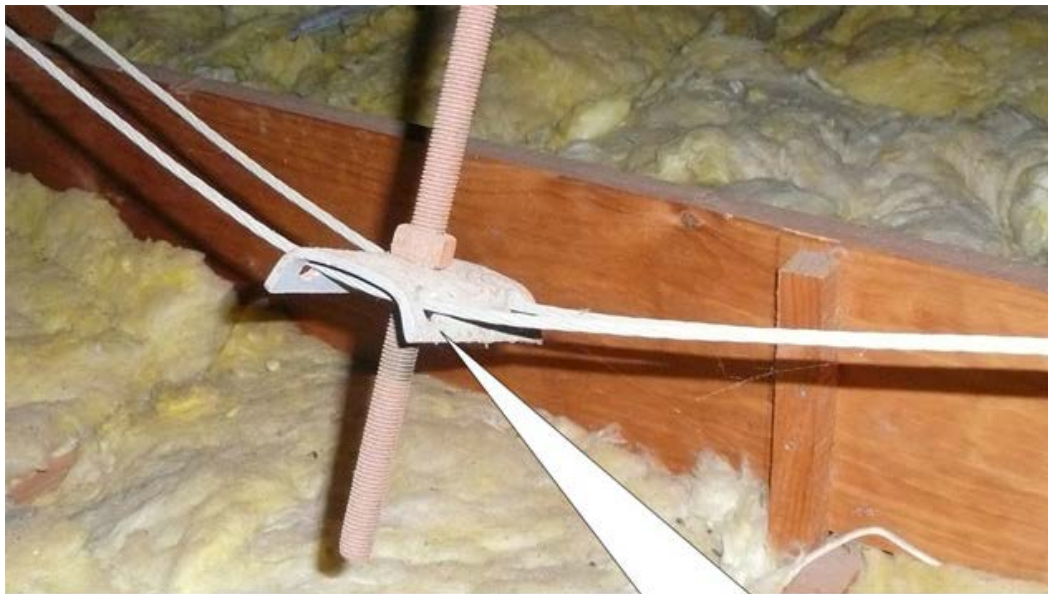
Example of the tensioning mechanism – the roof carpenter simply screws down the nut to tension the pair of cables

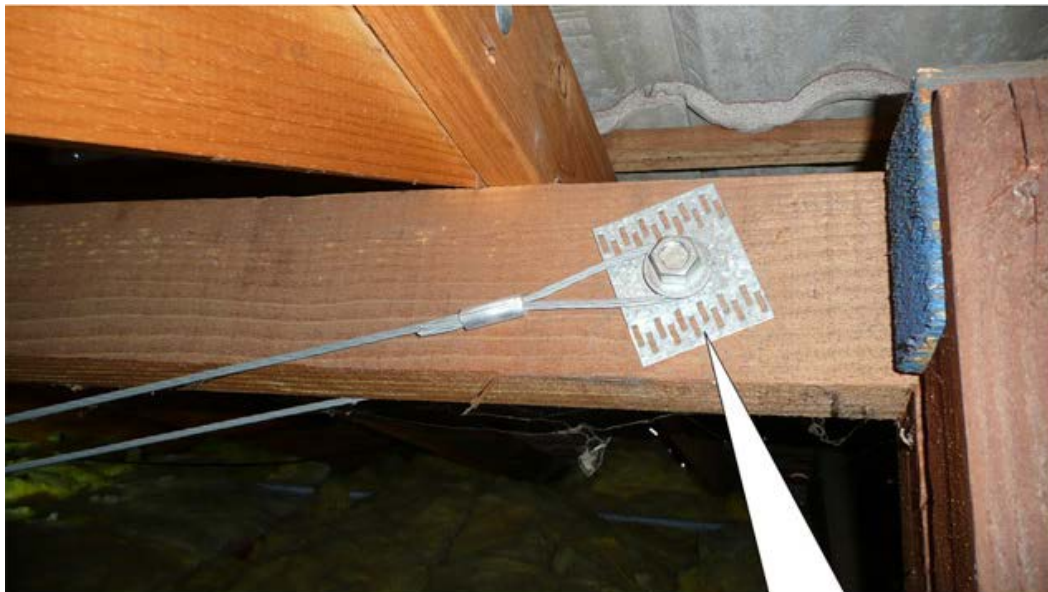
Example of the connection point for the cables

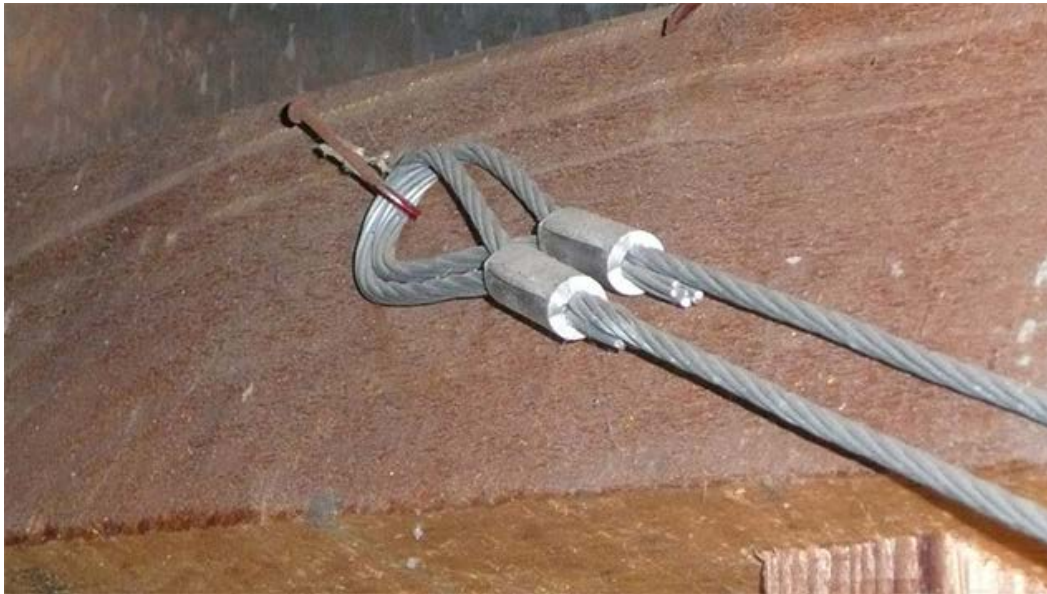
Below is an example of what was done to a connection, presumably by the installer of an evaporative air conditioning system: This was noted during a routine pre-purchase inspection of the home for a prospective purchaser.

The ends of the cables have been removed from their bolted connection and have been held on one side of the underpurlin by a nail. This renders the underpurlin bracing system useless.

Had the defect not been identified, the underpurlin could have been subject to failure, putting the structural integrity of the roof at risk.

The recommendation to the prospective purchaser was to have a first fix roof carpenter re-fit the swaged cables to a standard bolted connection through metal gang nail plates as per the previous photo.

In addition it was noted that a number of the cable braces elsewhere in this roofing system were loose so there was a further recommendation for the first fix roof carpenter to tension those braces.
